Invertebrate colonization of pier pilings in the Hudson River

Final report submitted to Hudson River Park Trust

February 2020

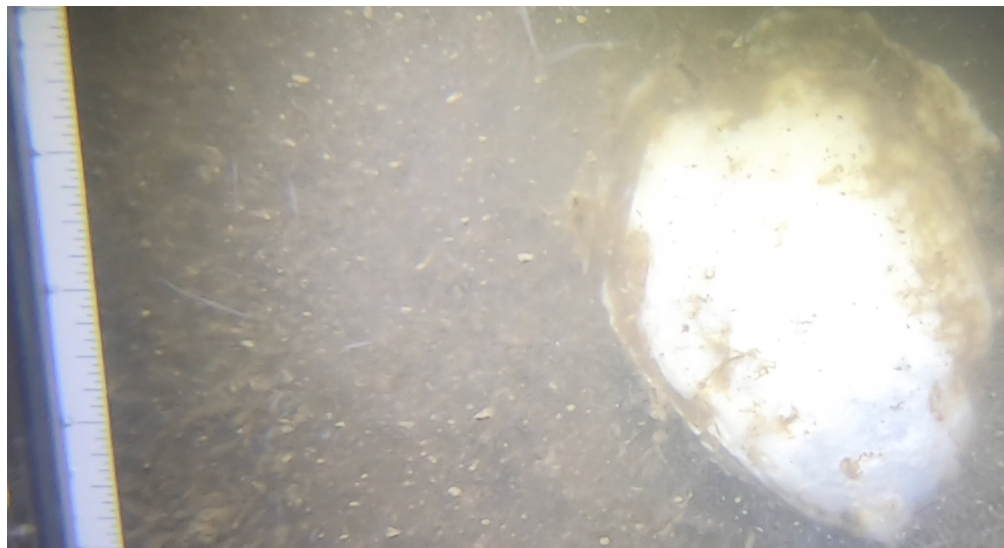
Photo 2: Large (~4cm) live oyster *C. virginica*, Pier 45. The ruler was left in frame to show size.

Oysters *Crassostrea virginica* were found on all piers, in varying amounts. Many scars (single valve still stuck to the pile), or box oysters (dead oyster but with both valves still attached) were found along with the live oysters. Oysters ranged in size, but there was a large percentage of the oysters above 4cm (possibly indicating an older age, but the shells were not dated). Shells were often covered in barnacles and other epibionts (e.g., sponge, encrusting bryozoan, or tunicates), but shells were relatively hard and

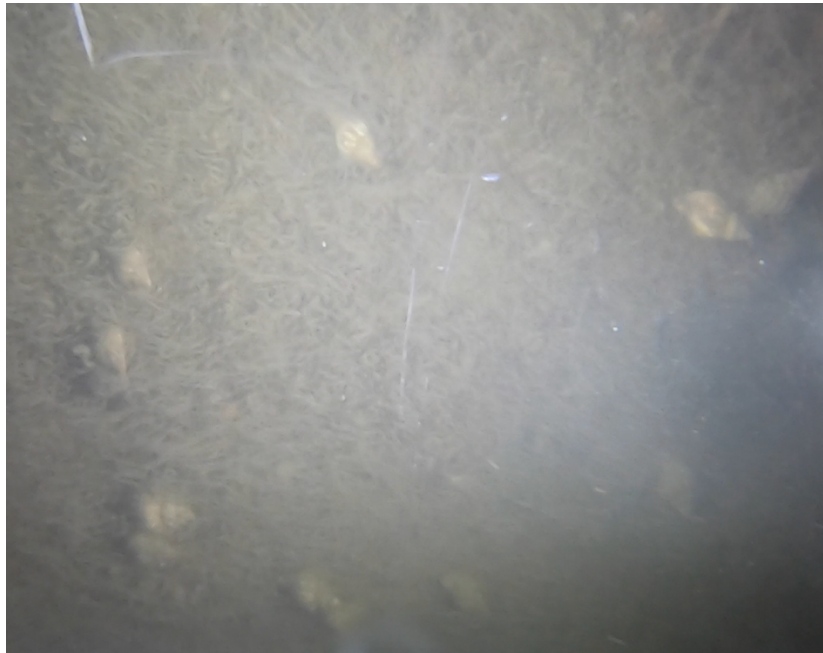
Photo 4: multiple oyster drill *Urosalpinx cinerea* snails, Pier 25.

One species of concern seen in videos was the oyster drill *Urosalpinx cinerea*. This predatory gastropod was observed on several piers, including Pier 45 and 84. In higher saline waters oyster drills occur in large densities and can destroy populations of oyster spat, though not usually a concern in the Hudson River, varying amounts of rainfall seasonally can affect salinity and may lead to a population boom of these predators. Oyster drills should be monitored around any restoration project to determine the percentage of mortality due to predators. It was not surprising to see oyster drills on piles since there was live oysters found there too. Drill “scars” (holes in shells) could not be observed in the video, but that may be due to their small size.

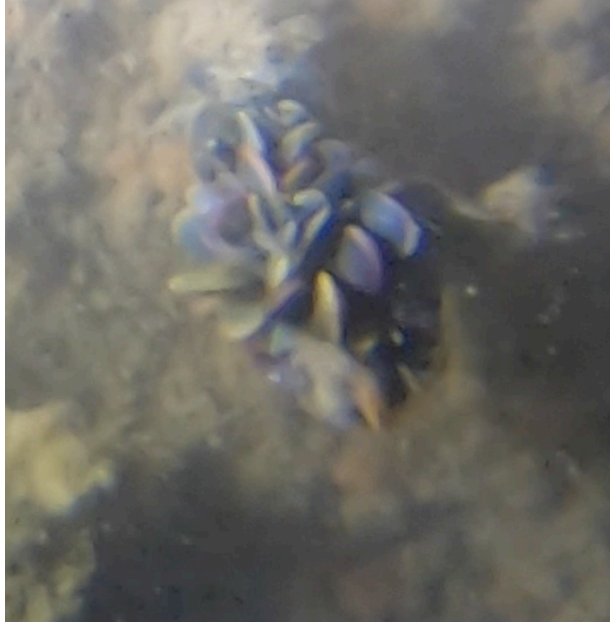
Photo 5: Clump of blue mussel *Mytilus edulis*, Pier 25

Mussels (both blue and ribbed) were found in moderate abundances around the pilings of all piers. These mussels use their byssal threads to attach to the piling, and to each other, to form dense clusters. Though mostly single (or double) mussels were observed, there were some clumps of 10-20 mussels observed on Pier 84. Mussels can filter nearly as much water as an oyster, and therefore are of importance when any calculations involving water quality are performed (e.g., when determining nitrogen removal rates or pollutant clearance rates for a system). Mussels may enhance biodiversity of

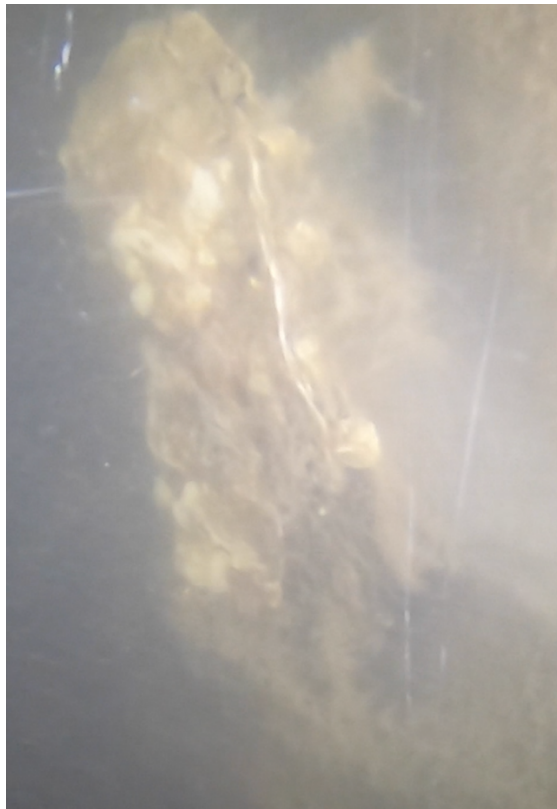
Photo 6: very large oyster (~6cm), Pier 25. Side view to show valves and closed edge.

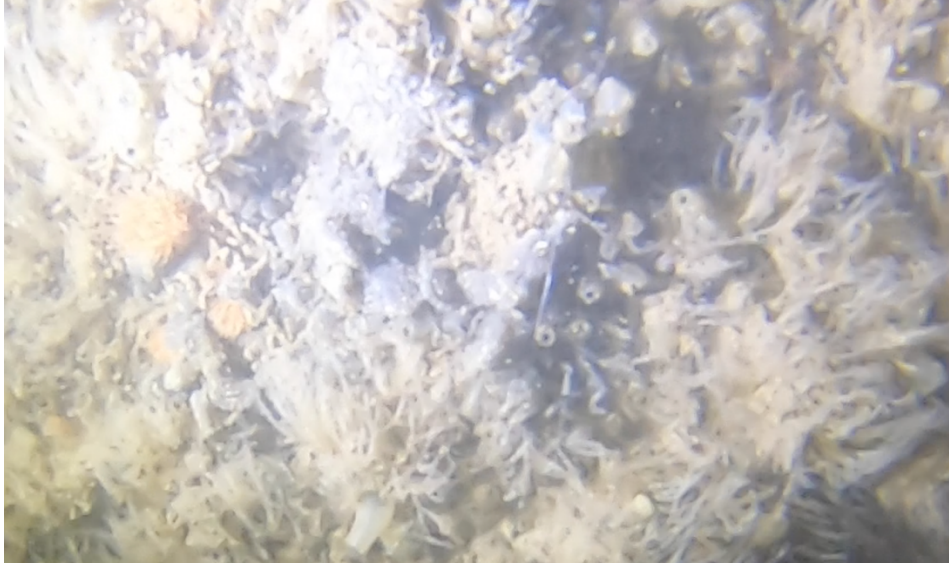
Photo 7: colonial tunicate (black), small anemones (orange) and bryozoan (white), Pier 25.

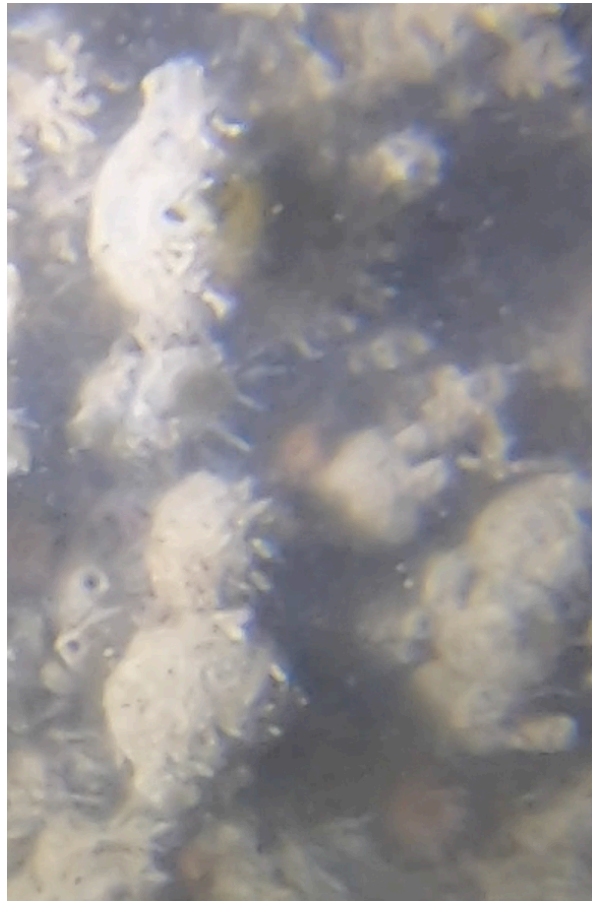
Photo 8: *Molgula manhattenensis*, Pier 25

were only found at the northernmost pier, Pier 84. Colonial tunicates as well as solitary tunicates (*Molgula manhattensis*) were observed on more southern pier, Pier 25.

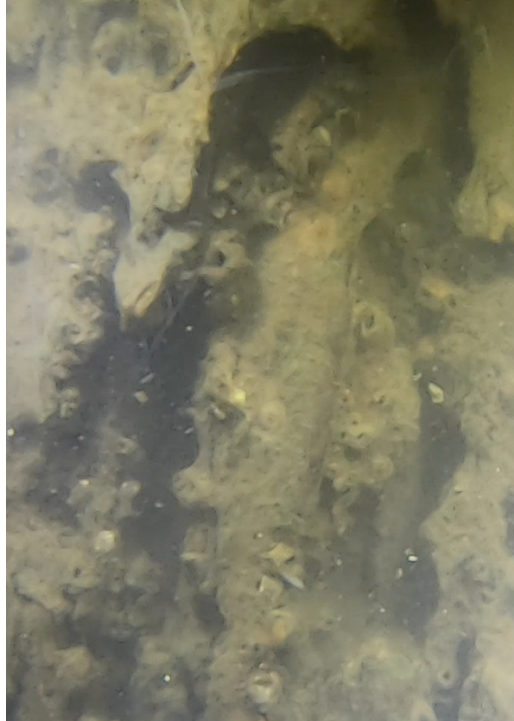
Photo 10: Pile erosion, Pier 32. It is possible this is from shipworms *Teredinidae*; no worms observed but markings consistent with shipworm damage.

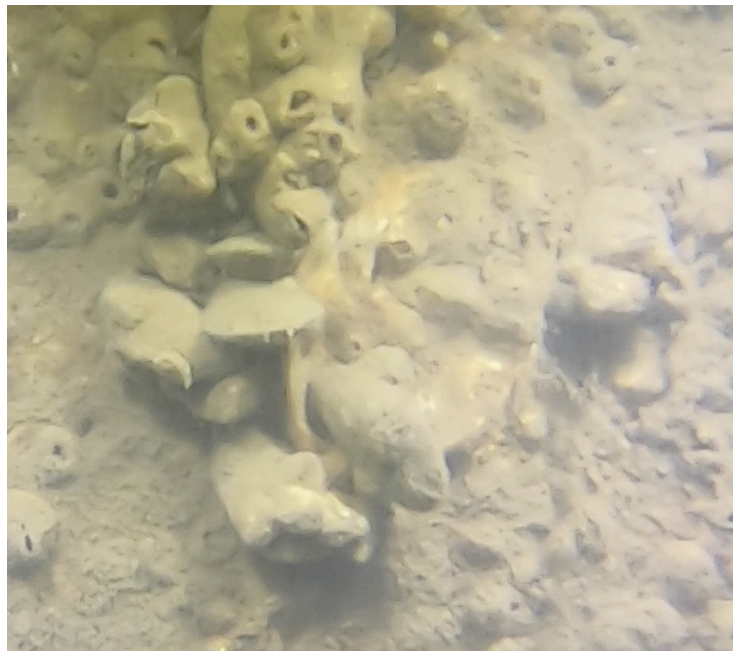
Photo 12: Ribbed mussels *Geukensia demissa* growing on an oyster scar, Pier 84.
